CANYON LEGACY

THE 1983 FLOOD

How the Glen Canyon Dam held up
under the impact of cavitation

by John Keys,
Former Commissioner
U.S. Bureau of Reclamation

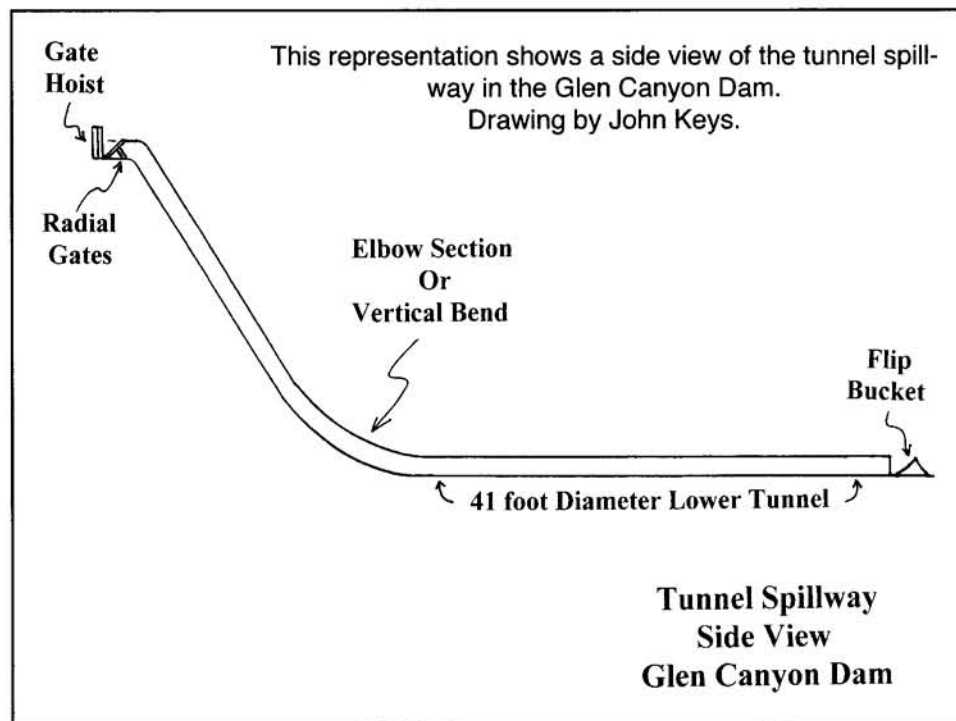
The photograph at left shows the large hole caused by damage to the left spillway. The hole was located just below the vertical bend in the spillway. Photograph courtesy the Bureau of Reclamation.

Extensive damage had been experienced in the vertical bend of the tunnel. Immediately downstream of the vertical bend, a hole 35 feet deep, 150 feet long, and 50 feet wide had been excavated in the sandstone by the high energy flows. Three-fourths of the tunnel liner circumference had been removed in the area of the large hole. In many other places near the vertical bend, the concrete lining was entirely gone, with reinforcing steel broken off by metal fatigue. A number of other smaller holes in the sandstone had been excavated, as can be viewed in the accompanying photographs and drawings.

With the spillways drained of water, adit tunnels (openings in the tunnel walls) were bored into the lower sides of each tunnel, near the outlet portals, to allow access to heavy equipment and trucks. The first task was to remove broken concrete, loose sandstone and other debris. Then the tunnels were prepared for new reinforced concrete to fill the holes and reinstallation of the concrete lining. The large hole in the left spillway tunnel actually took 2,500 cubic yards of concrete to fill.

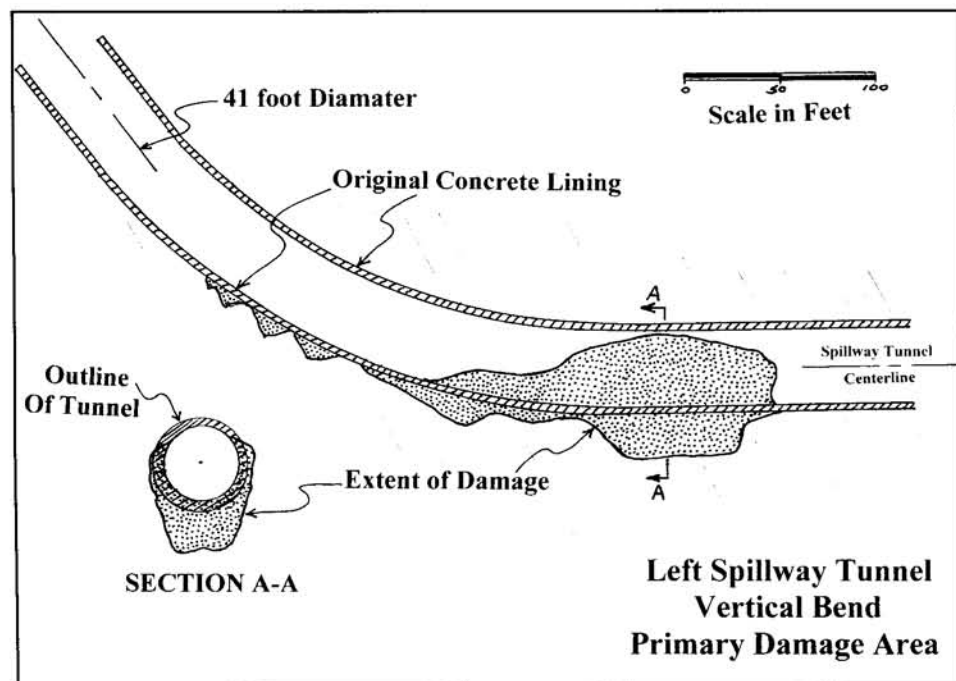
With these obvious signals of damage, the left spillway was closed for an inspection. A cart was lowered into the spillway. Almost 600 feet down the tunnel inspectors observed large holes completely through the three-foot-thick concrete lining. Some of the holes actually extended into the sandstone, and reinforcing bars from the concrete were twisted and broken. The cart could go no farther, but a series of large holes farther down the tunnel was observed.

The representation below shows damage to the left spillway that occurred in 1983 on the Glen Canyon Dam. Drawing by John Keys.

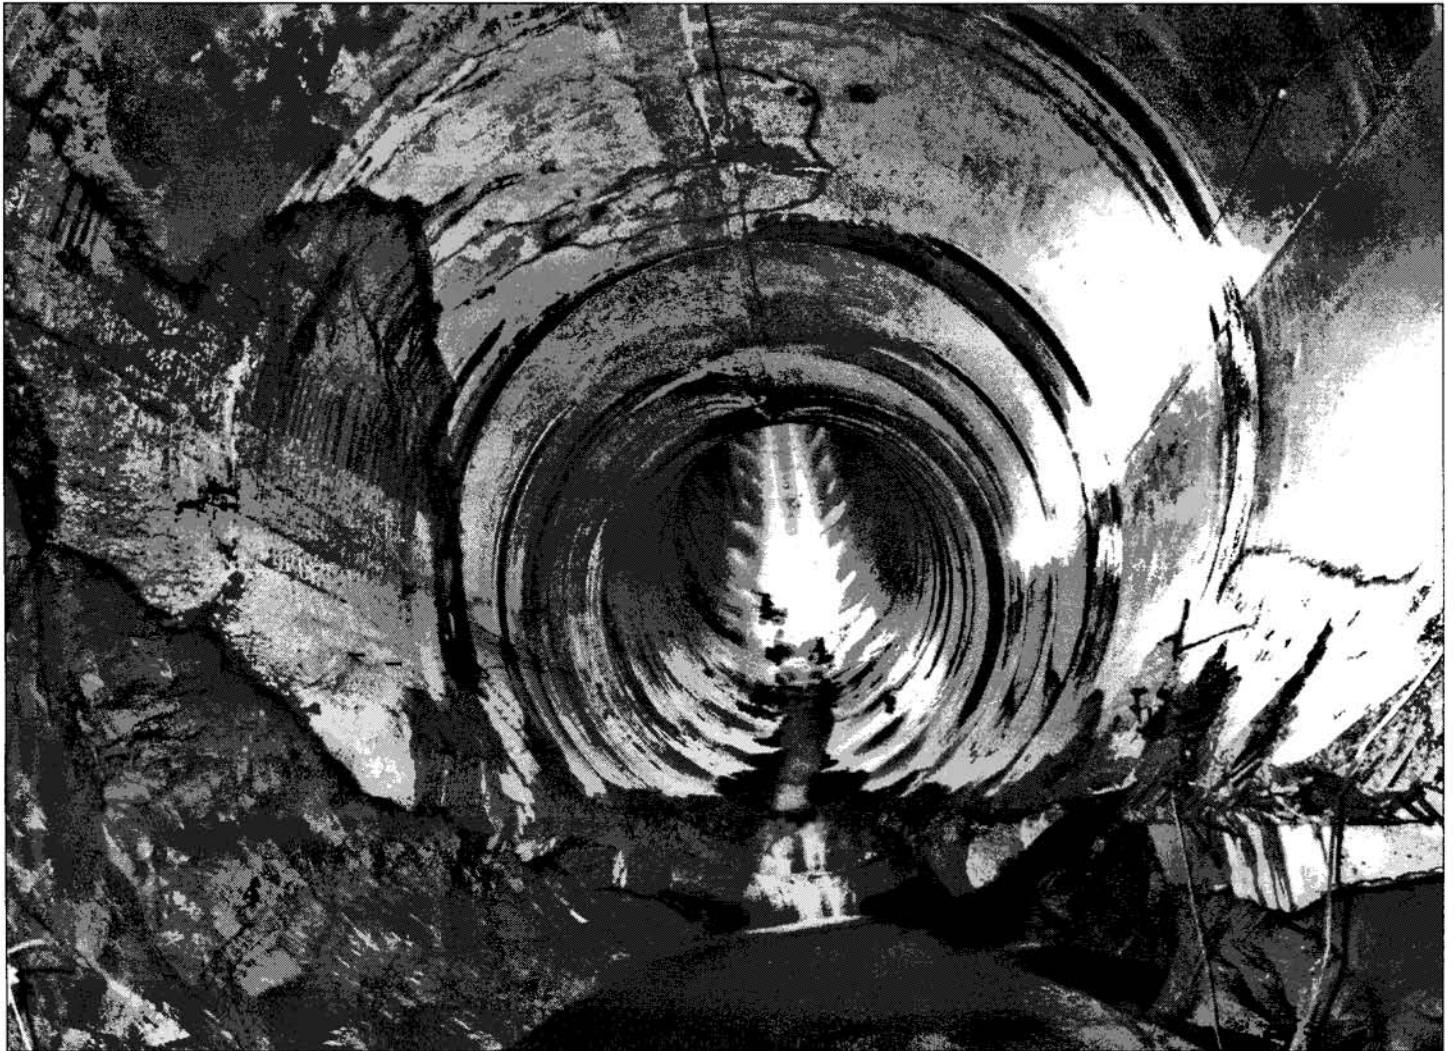
Inspection of the right spillway tunnel showed less damage. There was little debris in the flip bucket or tunnel. A large hole was found in the bottom of the tunnel immediately downstream of the vertical bend. The concrete lining had been removed for about 175 feet and sandstone had been excavated up to 12 feet deep. A number of other smaller holes in the lining and sandstone were found.

The photograph below shows an overall view of the elbow area of the right spillway. The concrete lining was eroded from left to right, and in the center is damage to the elbow area. Photograph taken on Sept. 21, 1983 by Tom Fridmann, courtesy the U.S. Department of Interior, Bureau of Reclamation.
